DA-H4A-DS

18G HDMI 2.0 1x4 DISTRIBUTION AMPLIFIER

Upgrade Instruction

Firmware Upgrade v.1.0.8

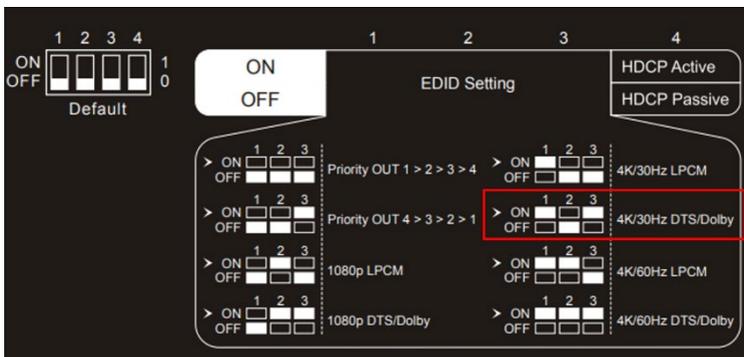
This EDID will replace the existing 3840x2160P 30Hz DTS/Dolby EDID located at DIP switch setting 101.
